# Safety Inspection Report

Annual Inspection

## Ewshot Recreation Ground

28 May 2024

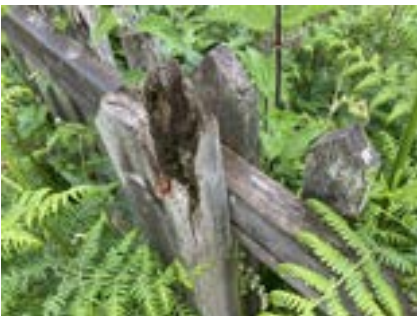
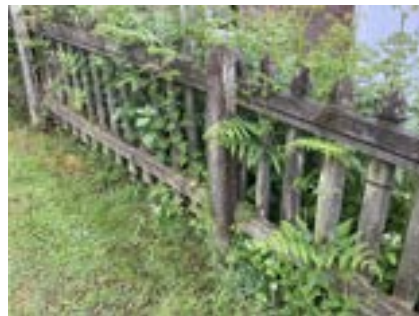
Timber is decayed.

Replace affected parts.

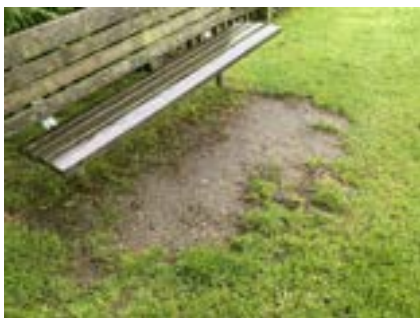
Ground erosion present.

Repair the worn areas.

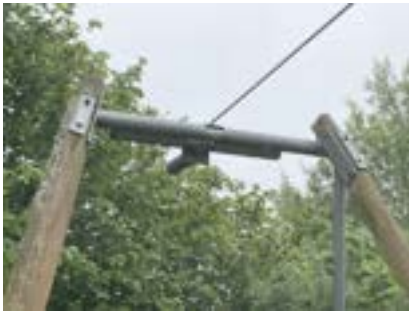
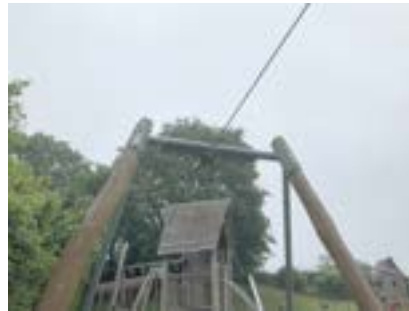
Cables have been known to fail under load due to wear and corrosion. This is generally where the cable enters into a tube, top bar, sleeve or similar, where the wire is in contact and wears and frays over time, but can happen anywhere on the cable. It is important to inspect any hidden parts at least annually. Damaged cables require replacement. This cannot be determined during an annual inspection, and is excluded from our inspection. This can lead to a high risk if no action is taken. Refer to the manufacturer's instructions to ensure the correct check is carried out.

Conduct an appropriate dismantling inspection.

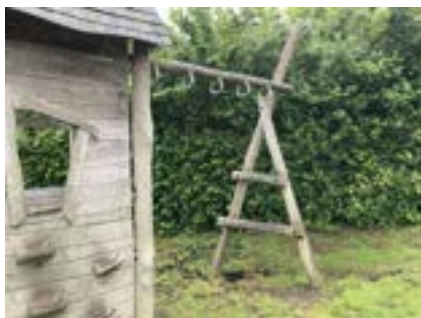
RoSPA is concerned by accidents on some types of overhead ladders and rings. However, there is a strong development value in these items.

The protective surface under all bars and rings must be kept in good condition.

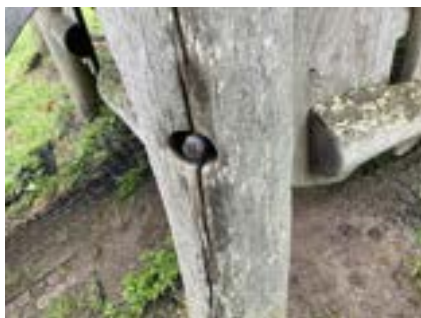
Cap missing.

Replace.

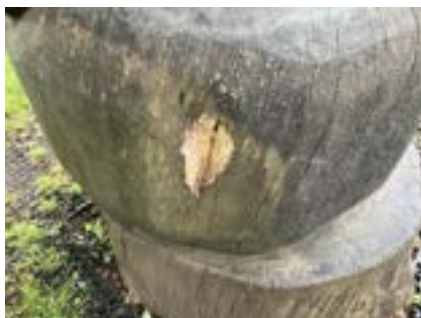
Timber is decayed.

Check on a routine basis.

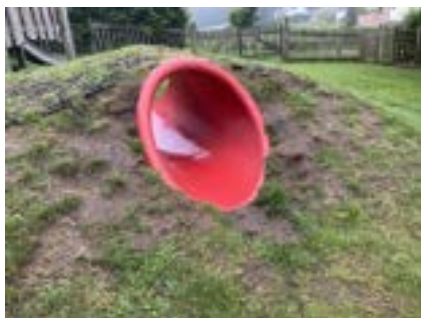
Surface is wearing.

Monitor for significant deterioration and rectify when necessary.

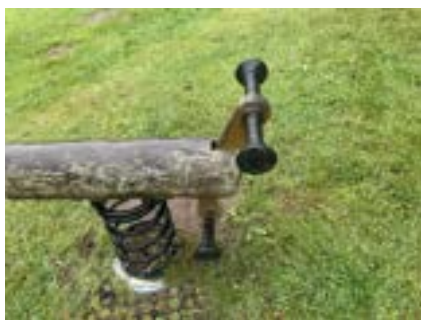
Fixtures loose or missing.

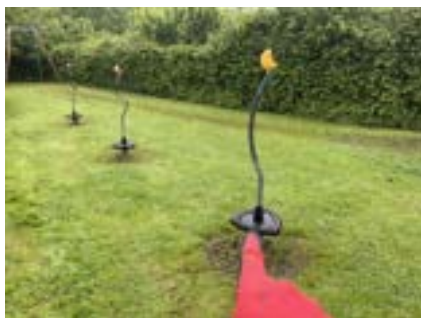
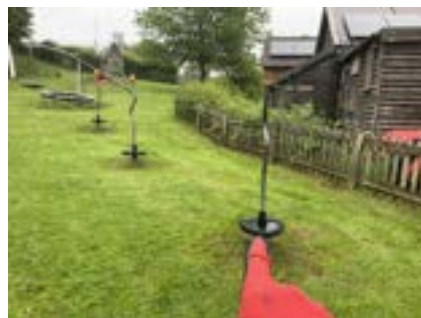
There is wear in the bearings.

Monitor and replace when necessary.

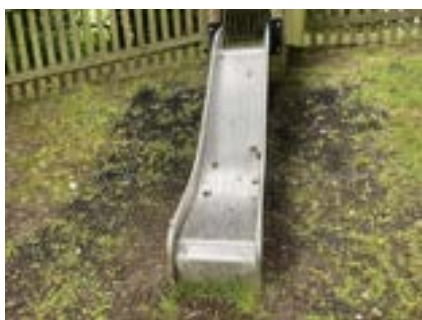
Description	Tasks	Risk score
Bird fouling present.	It is recommended that playground equipment be regularly checked for bird fouling - if found, the affected items should be cleaned with a disinfectant solution.

It is recommended that playground equipment be regularly checked for bird fouling - if found, the affected items should be cleaned with a disinfectant solution.

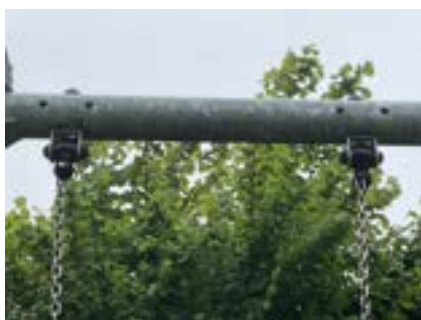
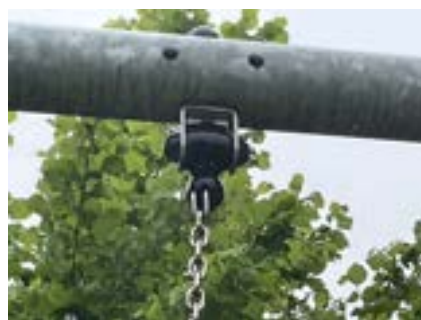
The covers should be removed from the fitting at the top of the chain annually and the shackle bolt should be checked for wear. Check the security of the fittings too.

Replace at 70% of original diameter (30% wear).
