Safety Inspection Report

Annual Inspection

Ewshot Recreation Ground

24 May 2022

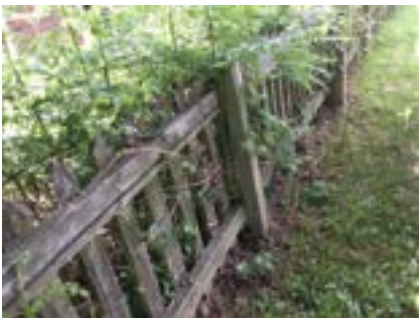
Boundary

Timber is decayed.

Replace affected parts.

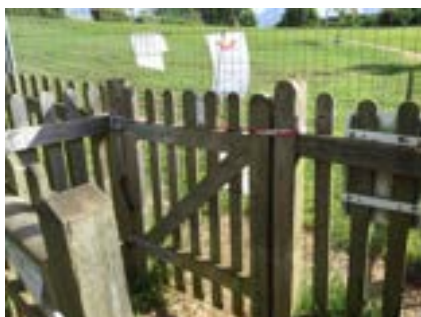
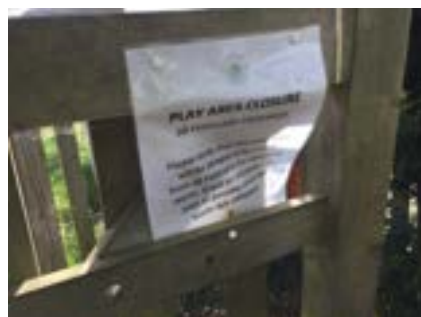
Gates

The play area is currently closed to allow the recently refurbished surfacing to establish.

Read the notes for further action.

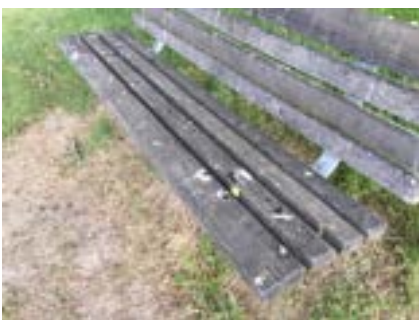
Seating

Bird fouling present.

It is recommended that playground equipment be regularly checked for bird fouling - if found, the affected items should be cleaned with a disinfectant solution.

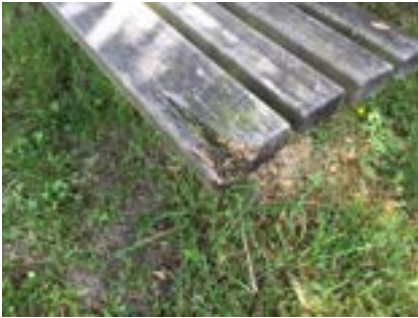
Timber is decayed.

Check on a routine basis.

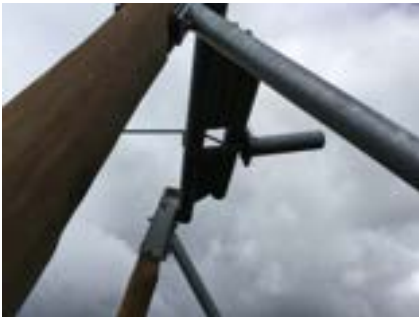
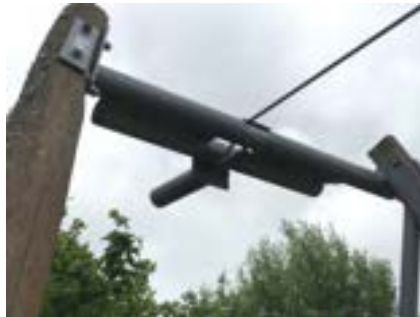
Cableway

Cables have been known to fail under load due to wear and corrosion. This is generally where the cable enters into a tube, top bar or similar, where the wire is in contact and wears and frays over time. Damaged cables require replacement. This cannot be determined during an annual inspection, and is excluded from our inspection. This finding is generically high risk and action is required. Refer to the manufacturer's instructions to ensure the correct check is carried out.

Risk level:
  **High**

Risk score:
  **13**

Conduct an appropriate dismantling inspection.

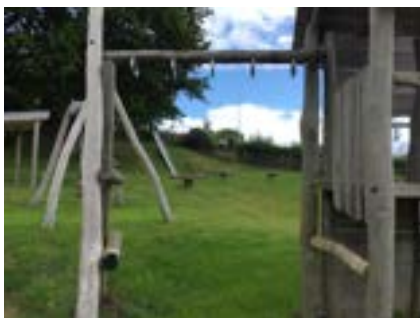
Multiplay - Junior

RoSPA is concerned by accidents on some types of overhead ladders and rings. However, there is a strong development value in these items.

The protective surface under all bars and rings must be kept in good condition.

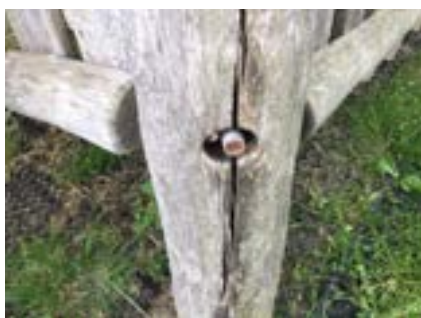
Multiplay - Toddler

Cap missing.

Replace.

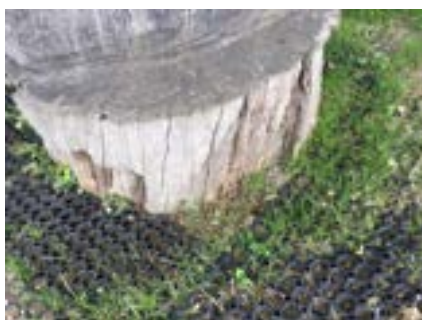
Play Feature - Squirrel

Timber is decayed.

Check on a routine basis.

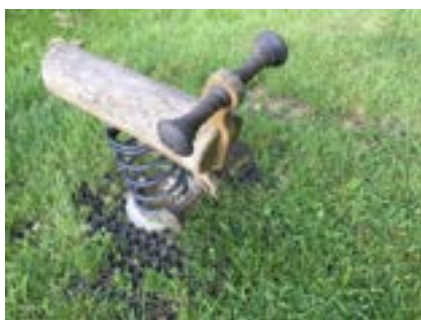
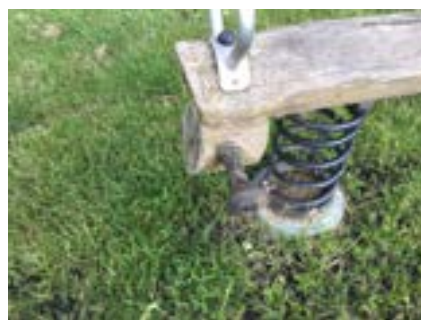
Rocker x 2

Fixtures loose or missing.

Foot rests and handle bar frame.

Tighten.

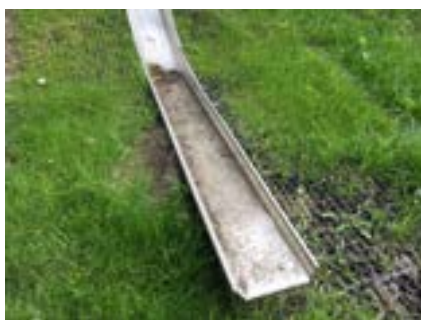
Slide - Embankment - Large

The equipment is dirty or algae covered.

Clean off.

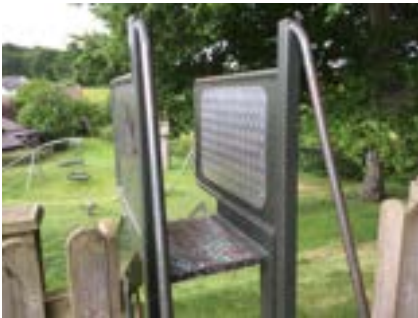
The item is not compliant with the requirements of the relevant standards. The surfacing meets with the requirements of the relevant standards.

The barrier height is below the minimum of 700 mm, when measured from the surface of the platform, stairs or ramp.

The unit was installed prior to the publication of the current standards. There is no requirement to make retrospective changes.

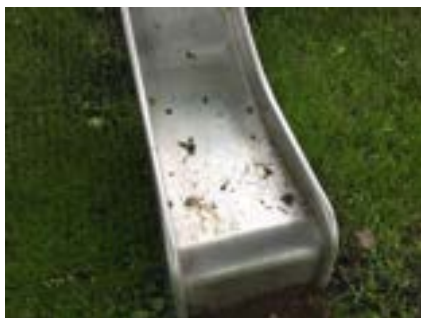
Slide - Embankment - Small

Bird fouling present.

It is recommended that playground equipment be regularly checked for bird fouling - if found, the affected items should be cleaned with a disinfectant solution.

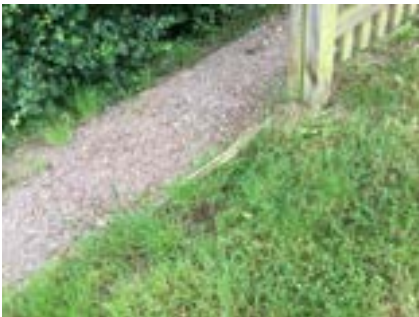
Trip points on the surface.

At slide access path.

Remove trip points.

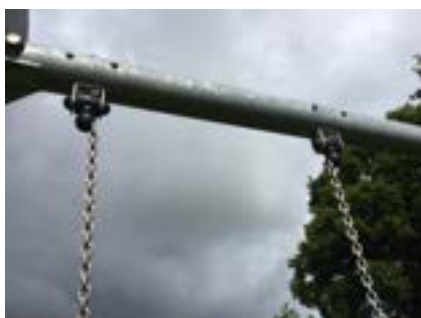
Swing - Toddler - 1 Bay 2 Seat

The covers should be removed from the fitting at the top of the chain annually and the shackle bolt should be checked for wear.

Replace at 70% of original diameter (30% wear).

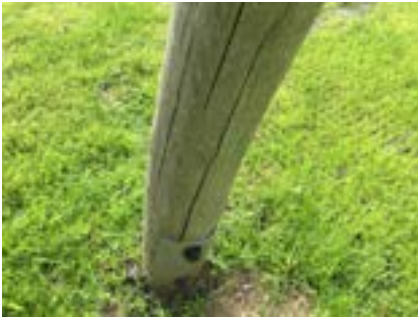
There are natural splits / shakes in the timbers.

Shakes vary. Monitor and consult manufacturer if dimensions exceed 8 mm at sections used to grip / grasp.
